# Case Study

## Installing Aerators to Improve Water Quality

**Location:** Cozumel, Mexico

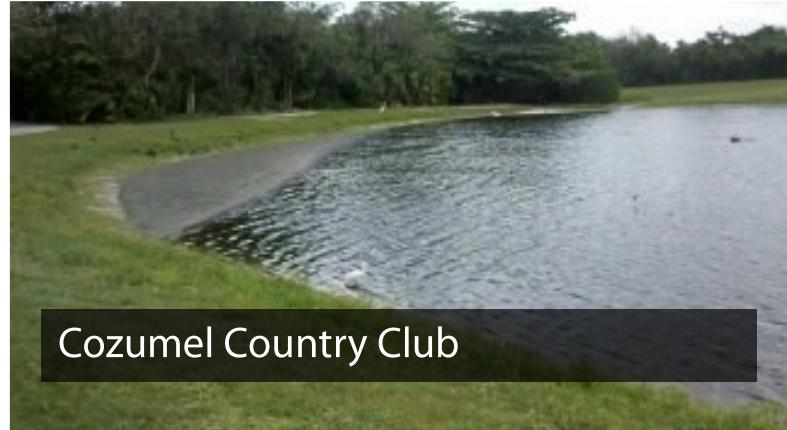
*Lake algae buildup after 3 weeks without aerator*

The irrigation lake at Cozumel Country Club is an effluent water storage lake with minimal rain runoff supplement. The golf club experienced varying degrees of issues with this lake, mostly unacceptable odor and algae growth. The staff determined that the most helpful (and eco-friendly) thing to do was to install an aeration system in the lake.

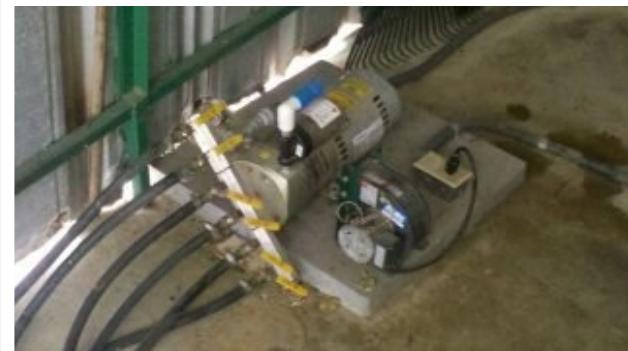
Aerator Compressor

The first step was to measure the lake size and depth in various areas. Then, the club contacted three different companies that sold and installed lake aerators for proposals on cost. After selecting one that best suited their needs and budget, installation started. The system, once installed, requires maintenance on the submerged aerator diffusers about every 3 to 4 months. The diffusers are weighted so they sit on the bottom of the lake. In this case, 6 different diffusers were installed, strategically distributed throughout the lake. They each have a float buoy tied to them, and are pulled up and are cleaned with a muriatic acid solution, brushed, rinsed off, and placed back in the original spot. The compressor also has a filter that has to be cleaned about every 6 months depending on conditions, and 4 carbon vanes that have to be inspected and replaced as needed. The club also purchased a small row boat for this maintenance process.
