Rain Gardens as a Wash Pad Alternative

Location: **Kennett Square Golf & Country Club, PA**
Type of property: **Private, 18-hole golf course**
Type of membership: **ACSP for Golf**

Kennett Square Golf & Country Club

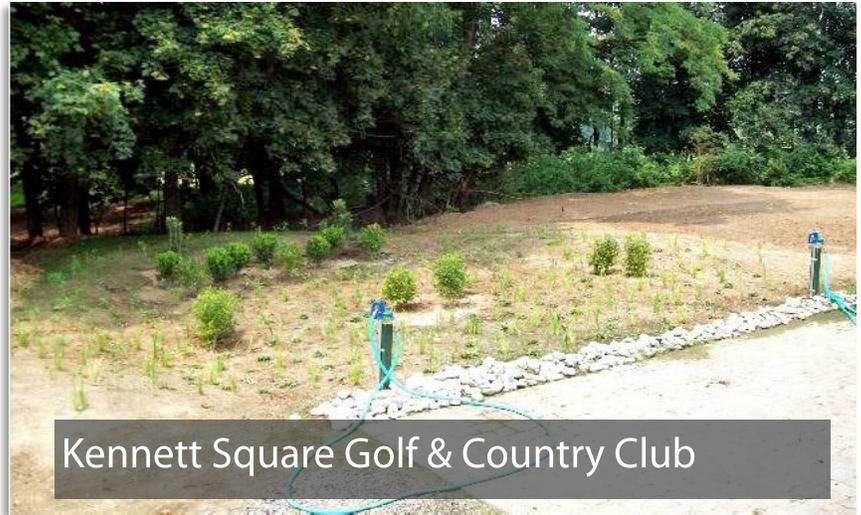
The solution that Stead and landscape manager Michael B. Loftus arrived at was the installation of a simple rain garden that doubled as filtration for the wash pad runoff. The first step in the project was to find an ideal location, away from Red Clay Creek and all other water bodies on the course. The wash pad, constructed out of concrete pavers, provided a spot for the equipment to be parked during washing. It was sized to fit two large pieces of equipment at a time. An eight-inch stone base and two inches of sand were laid beneath the pavers to ensure

that no settling would occur from the presence of heavy equipment. The wash procedure was also changed to reduce water usage and to limit the amount of clippings in waste water. Blowers are now used to remove excess clippings and mud from equipment prior to washing. To ensure that the wash water is properly filtered, a rain garden was installed as a runoff collection point. It was designed to be slightly depressed from the wash area, and the soil was amended to achieve a minimum infiltration rate of one inch per hour. Plants were installed to help filter the water as it infiltrates into the ground. Criteria for choosing the plants included water tolerance, native status, providing food and shelter for song birds, hummingbirds and butterflies, and providing year-round interest (a variety of blooming seasons). A two-foot wide strip of rocks was placed between the wash pad and rain garden to collect and remaining grass not removed by blowers, and slow the flow of water entering the rain garden.
